**HISTORIC RESOURCES DOCUMENTATION
FOR THE
SOMERS TIE PLANT
SOMERS, MONTANA**

Submitted to:
The Montana State
Historic Preservation Office

Submitted by:
Burlington Northern Railroad

December 1990

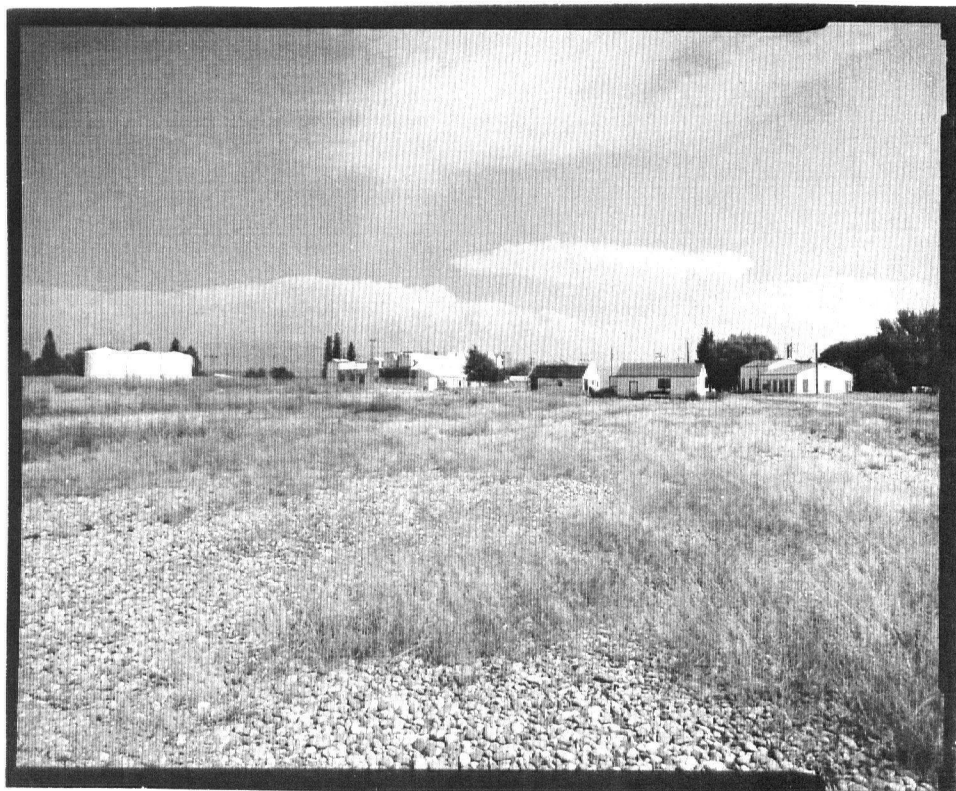
| HAER MT-86-2 | Looking southeast at the existing structure. The tie plant is in the center of the photo. |
